## **FIRMWARE UPDATING FOR THE JUMA TRX2 & PA100D**

The Juma TRX2 transceiver and PA100D linear amplifier are designed in such a way as to permit easy updating of their firmware as modifications, enhancements, and bug fixes become available. This note describes the procedures employed.

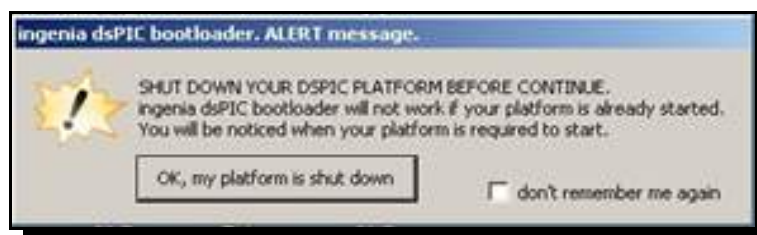
1. Connect the transceiver or amplifier to the PC serial port or USB-RS-232 convertor using the appropriate serial cable.
2. Ensure the transceiver or amplifier is switched off.
3. Launch the Ingenia loader by clicking on its icon on the desktop. You should receive the following display:

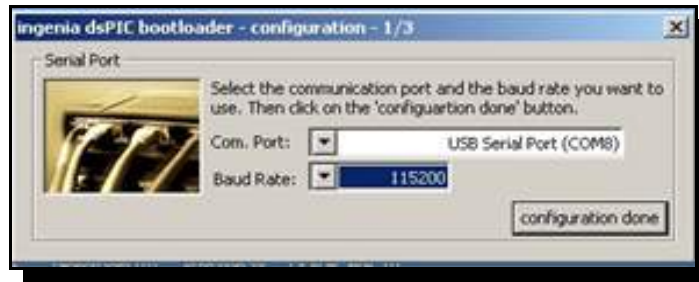
4. Click on the tab: 'OK my platform is shut down', and you should receive the following display:

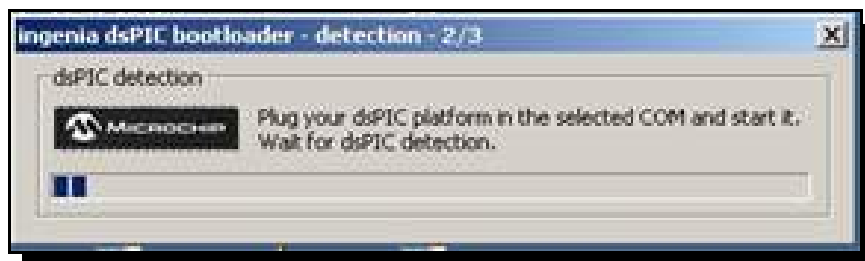
5. Click on the Com Port tab and select the serial port your intend to use. Normally the program locates the correct port automatically. Then click on the Baud Rate tab and select the speed if you do not wish to use the default of 115,200 baud. Finally click on the 'configuration done' tab, whereupon you should see the following display:

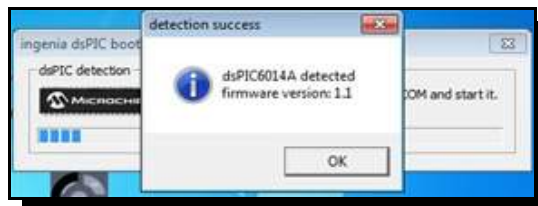
6. Press and hold the VFO button on the transceiver, and then press the PWR button to turn it on. The transceiver will display a message that the flash writer has started. Wait until you receive the message that the Ingenia loader has recognised your platform. When it has been recognised, you will see the following display:

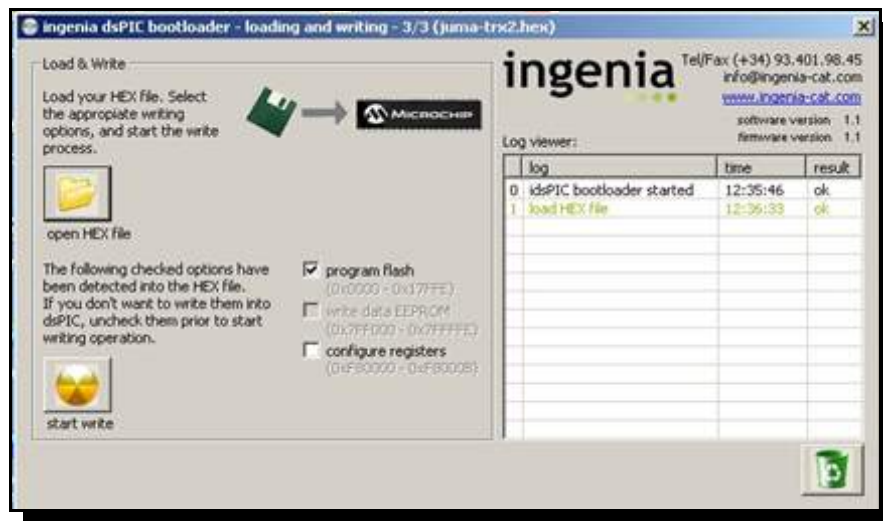
7. Click on the 'open HEX file' tab, and navigate to the folder where your HEX load file typically named as: *juma-trx2.hex*, is located, double click it to select and load it, and you should see the following display:

2. If an error message is provoked when opening the HEX file in step 7, this may indicate that either the HEX file has been corrupted, or that the installation of the Ingenia loader was incorrect. Download the HEX file again, and compare its 32-bit CRC with the original. Re-install the Ingenia loader and make sure that the configuration XML file is replaced.

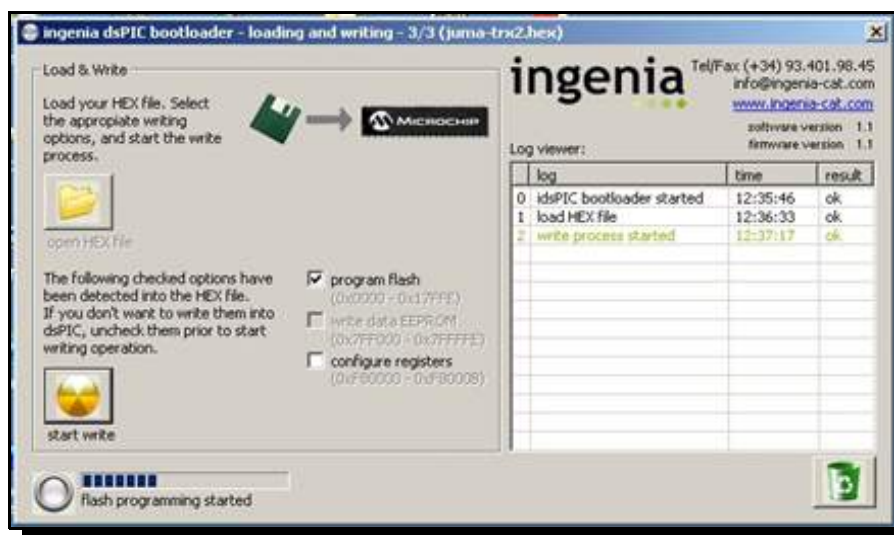
8. Ensure that the 'program flash' box is checked, this should happen automatically as the HEX load file contains the necessary settings to do this. None of the other check boxes should be selected, nor should there be any error messages. Click on the 'start write' button, and you should see the following display:

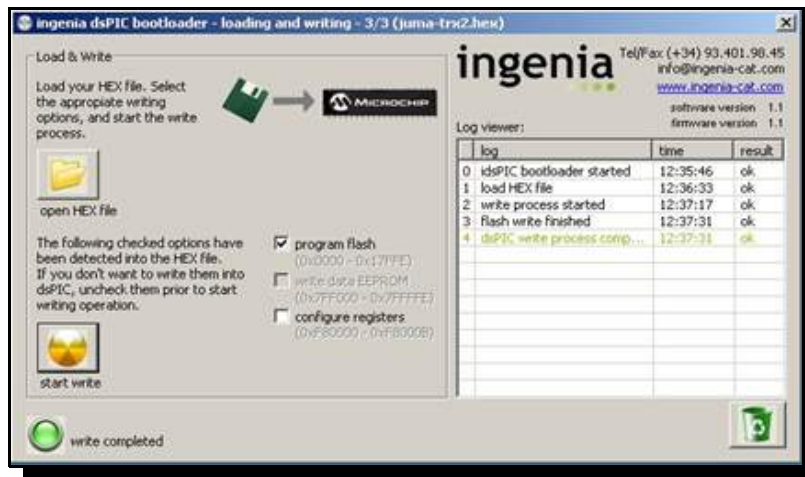
9. The progress bar above the message 'flash programming started' should smoothly increment, and the programming operation will takes about 10 – 15 seconds at 115,200 baud. At the successful conclusion of the flash writing, you should see the following display:
